Using Land-based Photogrammetry to Monitor Sandbar Stability in Grand Canyon on a Daily Time Scale

Leland R. Dexter, Brian L. Cluer,¹ and Mark F. Manone

*Department of Geography
Northern Arizona University
P.O. Box 15016
Flagstaff, Arizona 86011*

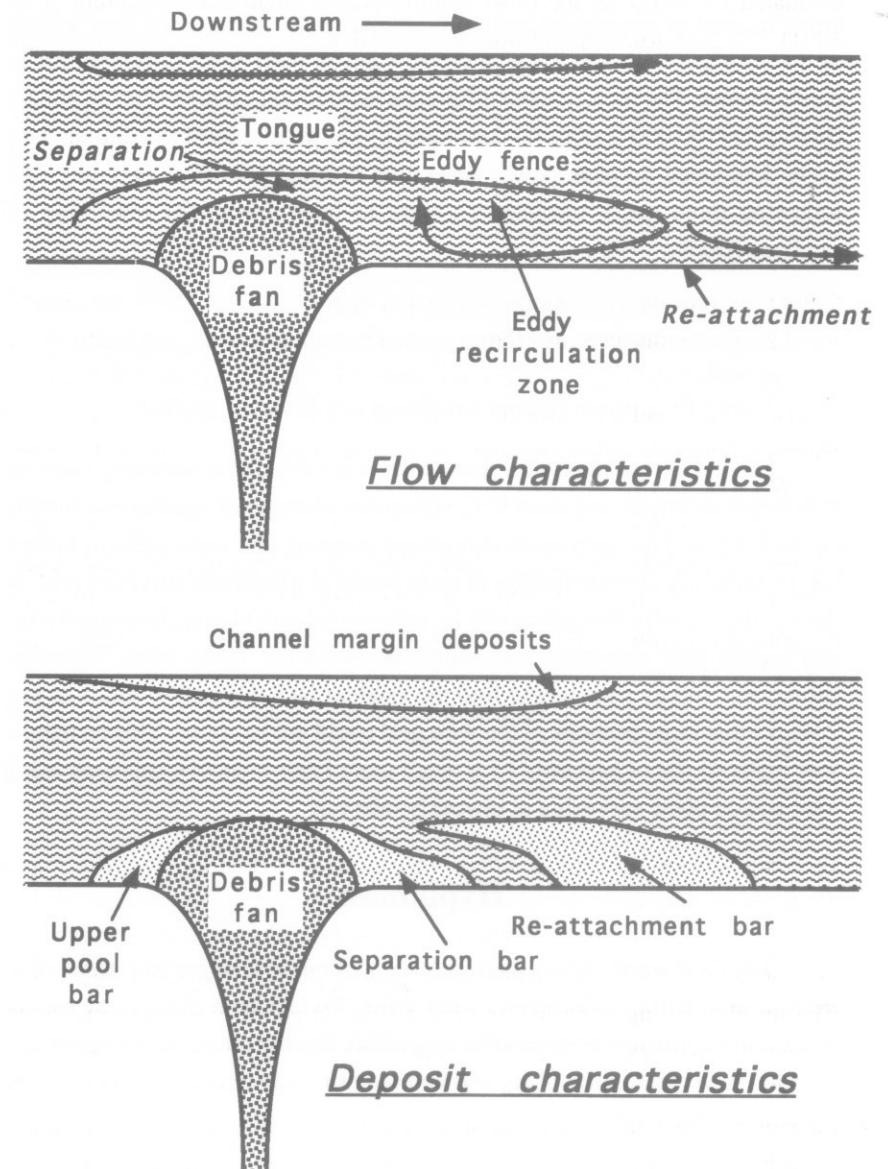
Fig. 1. The major hydraulic components of a Grand Canyon rapid (top) and the resulting alluvial deposits (bottom).

Most sandbars form in predictable locations based on the interaction between river hydraulics and landform features of bedrock or boulders. Typically, runoff from intense localized storms drains down steep-gradient tributary canyons and produces bouldery debris fans at the mainstem confluence. The debris fan constricts the mainstem channel and creates supercritical or shooting flow of the rapid. The supercritical flow separates from the bank near the toe of the debris fan and leaves a low velocity, recirculating eddy zone downstream of the fan and a bounding shear zone between the shooting flow and the eddy zone called the eddy fence. As the shooting flow of the rapid decelerates, the flow reattaches to the bank at some point downstream (Fig. 1; Schmidt and Graf 1990; Bauer and Schmidt 1993).

Sand and finer grain clastics are within the critical particle size range for erosion, transportation, and deposition in these types of hydraulic environments. The usual resulting deposits are visible (Fig. 1) under low-stage conditions. Typically, sandbars are found along the upstream face of the debris fan (upper pool bars), along the downstream face of the fan in the quiet water of the eddy (separation bars), and at the stagnation zone of the flow attachment (reattachment bars). Other depositional environments include point bars on the insides of meanders and thin channel margin deposits not otherwise associated with debris fans or meanders. In addition, a poorly quantified volume of sediment is stored subaqueously on the channel bottom (Schmidt and Graf 1990; Bauer and Schmidt 1993).

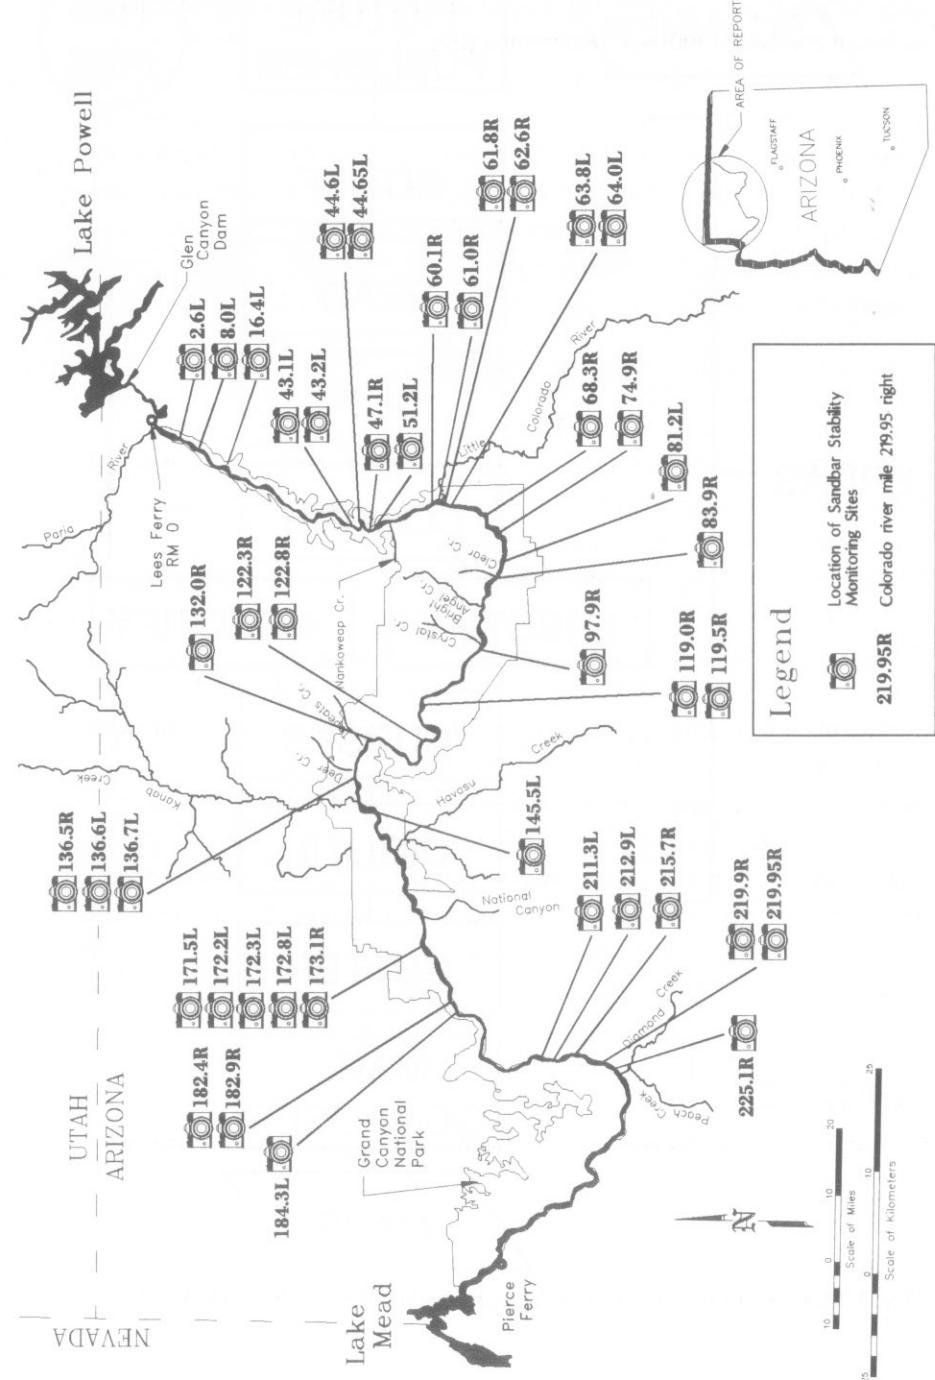
Fig. 2. Site index map for sandbars and camera stations used in this study.

were included in the sample, and each of the five major geomorphic reaches (Schmidt and Graf 1990) was represented (Fig. 2).

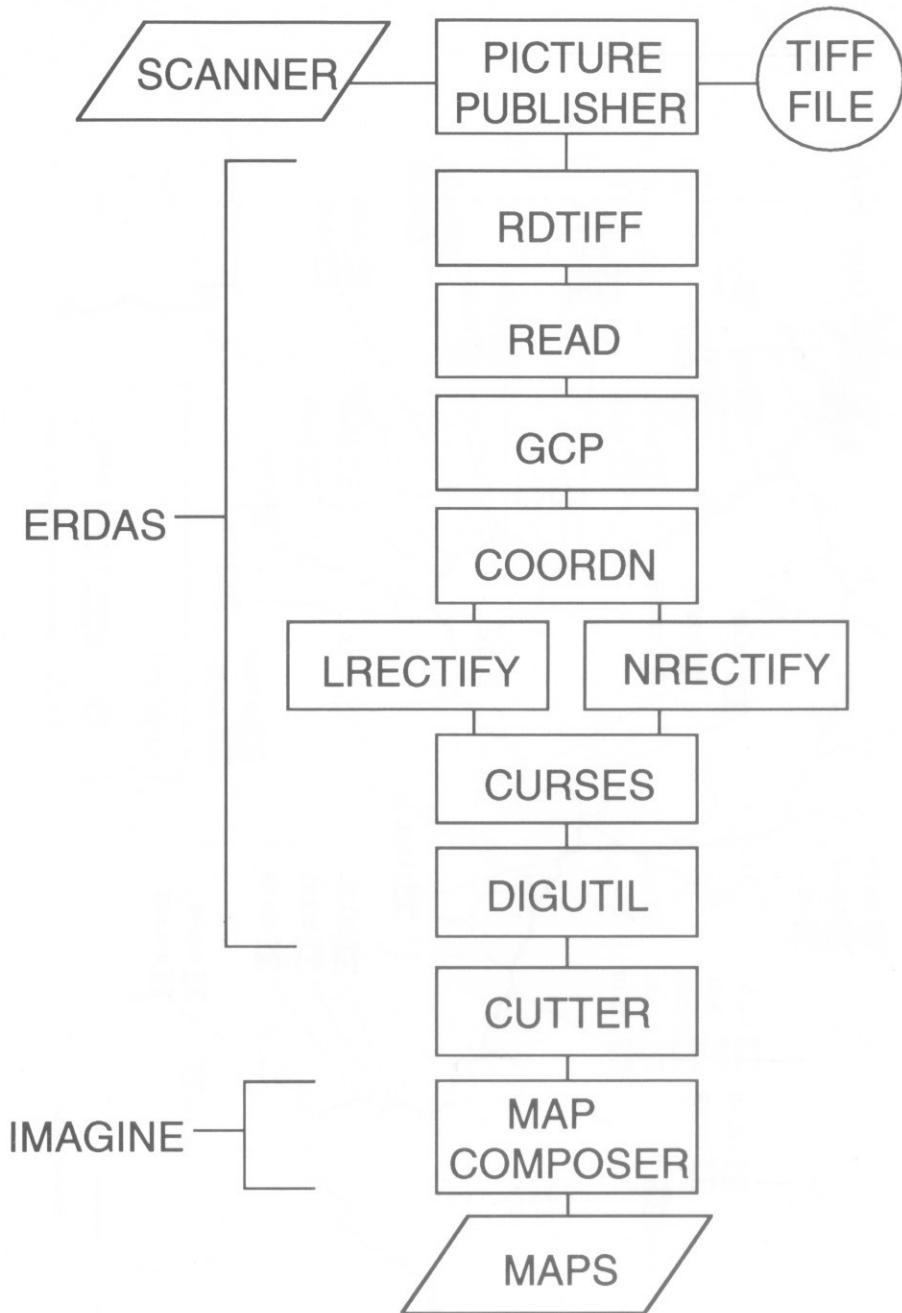
Fig. 3. Major image processing procedures and modules used in this study.

Film was processed conventionally and left in strips to facilitate scanning. A Nikon high-resolution slide scanner was used to convert the image to digital form. The digital tagged image format file (TIFF) created by the scanner was controlled by using Picture Publisher software. The image was imported into ERDAS V.7.5 for image rectification and analysis (Fig. 3; ERDAS 1992).

The resulting queried coordinates reflected a cumulation of all errors propagated through the system when used in a manner we were likely to employ in our spatial analyses. These queried coordinates were obtained using the CURSES module of ERDAS (Fig. 3). When the queried coordinates were compared to the surveyed coordinates for the panels, a Euclidean distance error could be computed for each panel withheld.

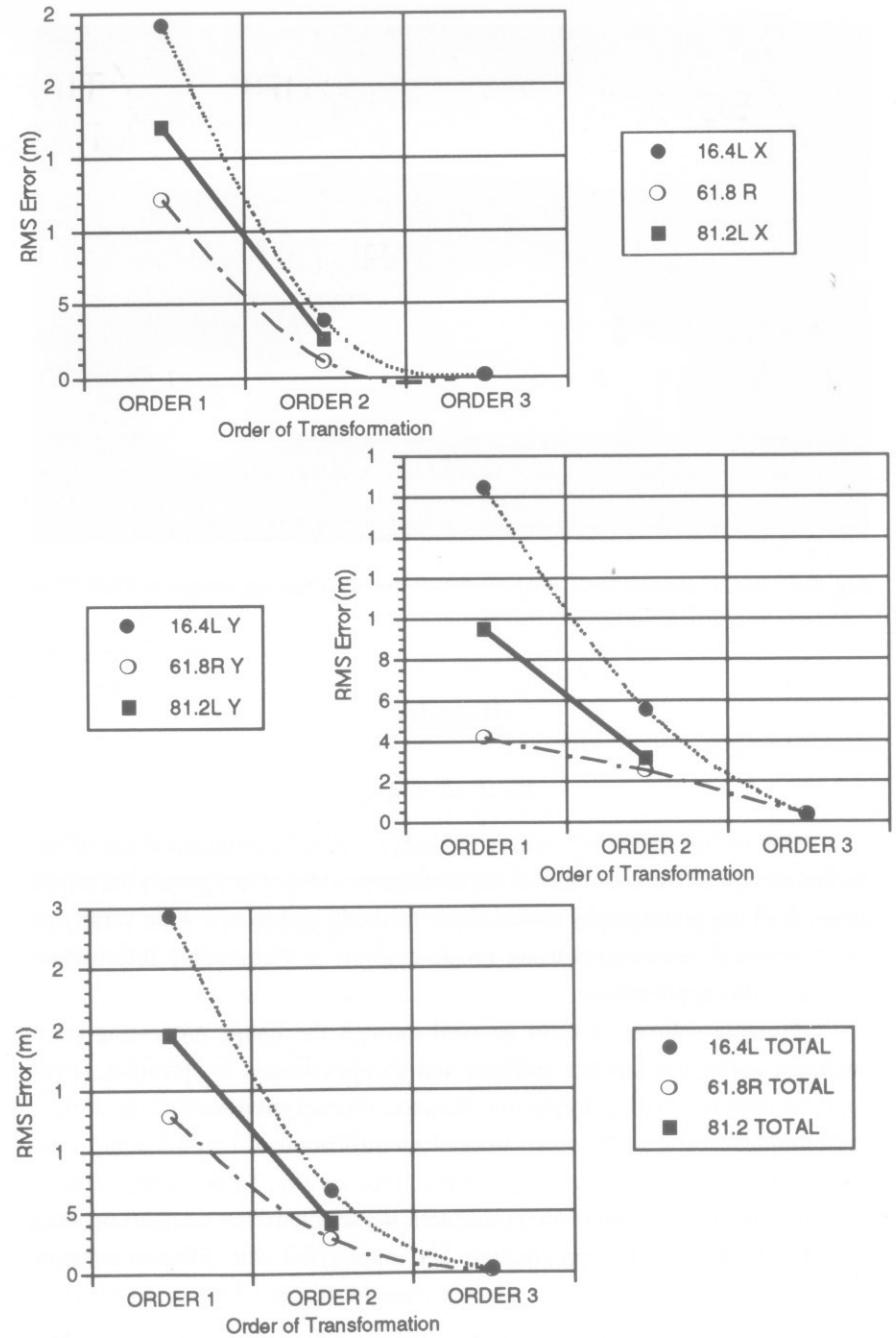
Fig. 4. Transformation order versus RMS error as reported by ERDAS.

The image had to be rectified from an oblique view to a planimetric view. The pixel locations of the control panels in the image were matched with the precisely surveyed coordinates of the same panels on the ground through a transformation equation. A variety of transformation equation orders or exponential powers may be applied. The benefit of higher order equations is a reduced root mean square (RMS) error between image and ground (Fig. 4).

Order three transform RMS suggests better than 1 in 100 spatial accuracy at an alpha level of 0.05 or 95% confidence (Fig. 4). Therefore, the techniques used here allow us to come within 1 m of planimetric position for 95% of the point positions sampled.

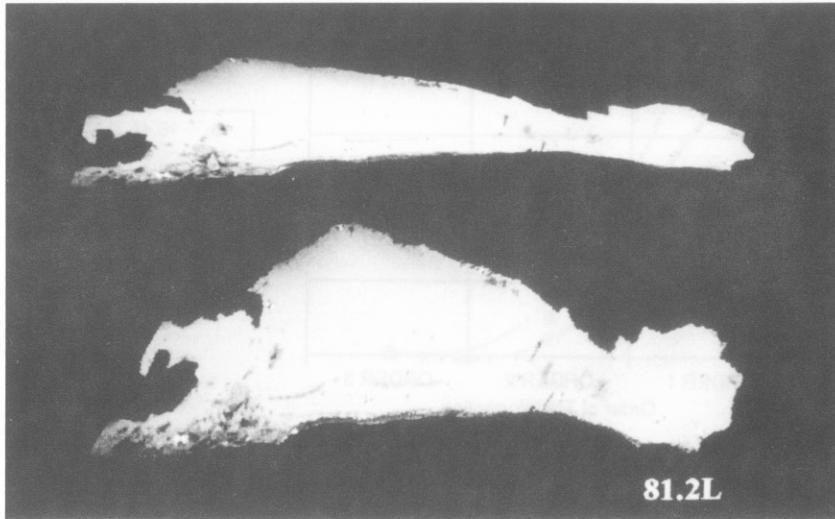
Fig. 5. Pretransformation (*top*) and post-transformation (*bottom*) images in ERDAS of 81.2L showing control panels in place.

Once the images were rectified to approximate the planimetric view, various area and outline shape related analyses were performed. These analyses include total area of subaerial sand cover and daily lateral erosion or deposition rates based on a comparison of sequential images (Fig. 5). Estimates of height change and sand volume cannot be made with single-camera photogrammetry. In addition to the measurements, the original oblique views or the rectified views were sequenced into high-speed video loops for improved visualization and understanding of sandbar dynamics.

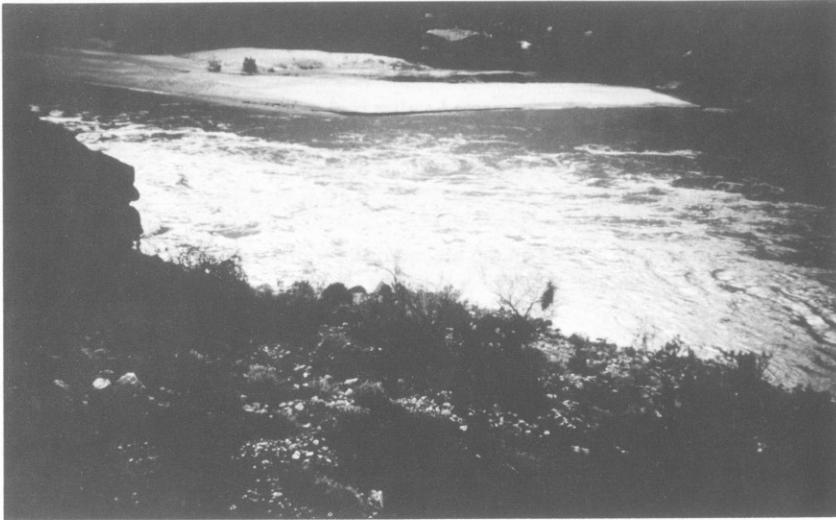
Fig. 6. Sandbar at 215.7R on 13 March 1993, prefailure.

Figures 6 through 10 illustrate oblique views of two typical sandbar failures. Figure 6 shows 215.7R on 13 March 1993 and Fig. 7 is the same sandbar 1 day later (14 March 1993). Note the loss of several meters. Figure 8 shows 16.4L (Hot Na Na) on 22 October 1992. The same sandbar 1 day later (23 October 1992; Fig. 9) shows seepage failure with water loss in progress. The photograph for 24 October 1992 (Fig. 10) shows the full extent of the failure. Figures 11 (18 June 1991), 12 (19 June 1991), and 13 (1 July 1991) show the sandbar at 172.3L, an active bar as described above. Figures 11 and 12 reflect only 1 day of difference and are indicative of the rapid rate of failure. Two weeks after the 19 June failure, the bar was gradually rebuilding (Fig. 13).

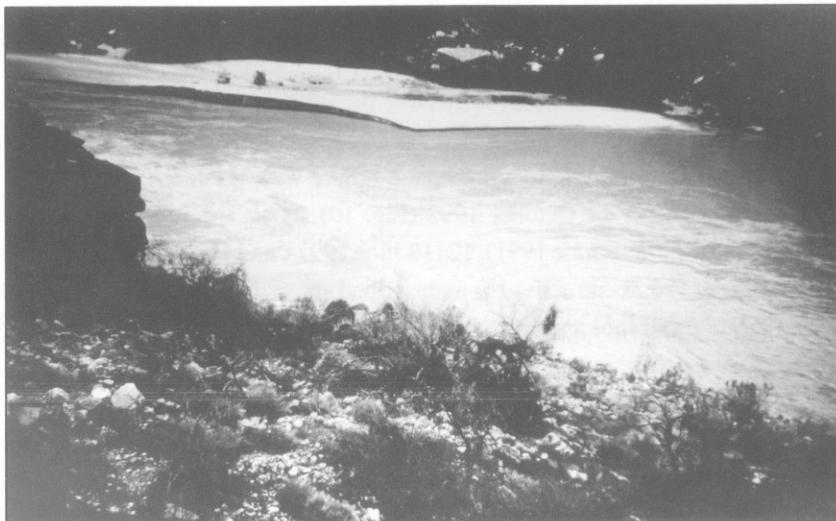
Fig. 7. Sandbar at 215.7R on 14 March 1993, postfailure.

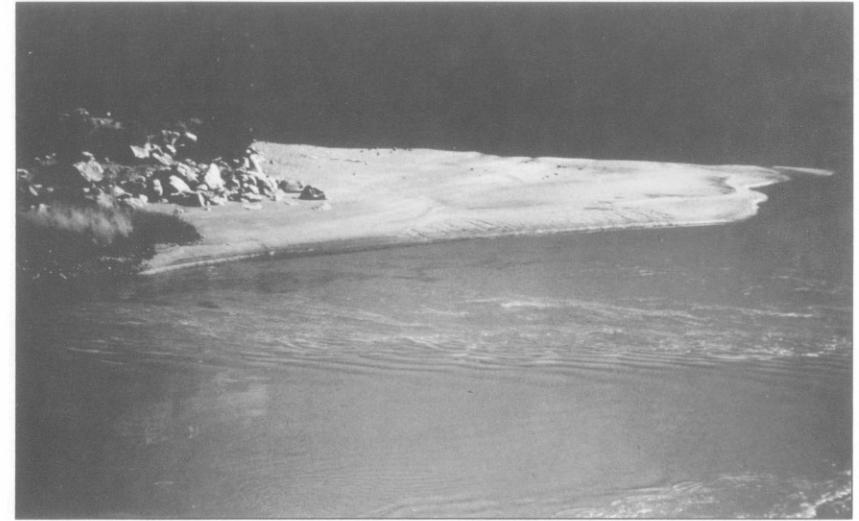
Fig. 8. Sandbar at 16.4L on 22 October 1992, prefailure.

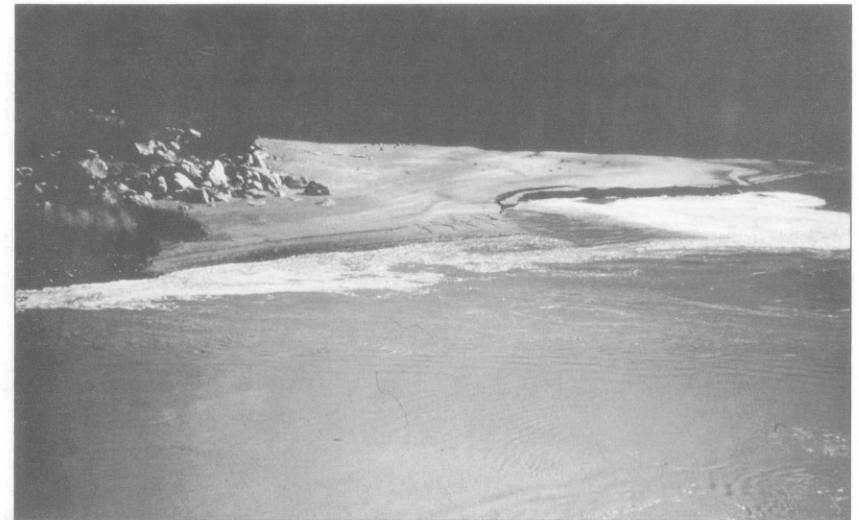
Fig. 9. Sandbar at 16.4L on 23 October 1992, during failure.

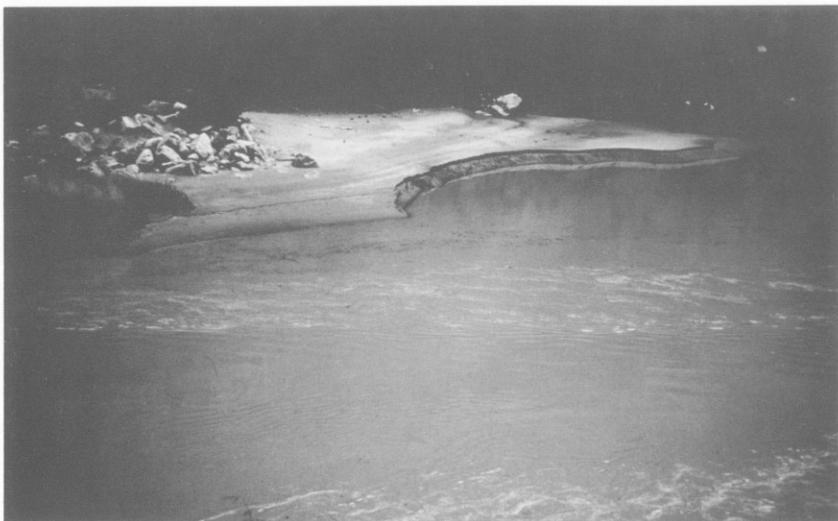
Fig. 10. Sandbar at 16.4L on 24 October 1992, postfailure.

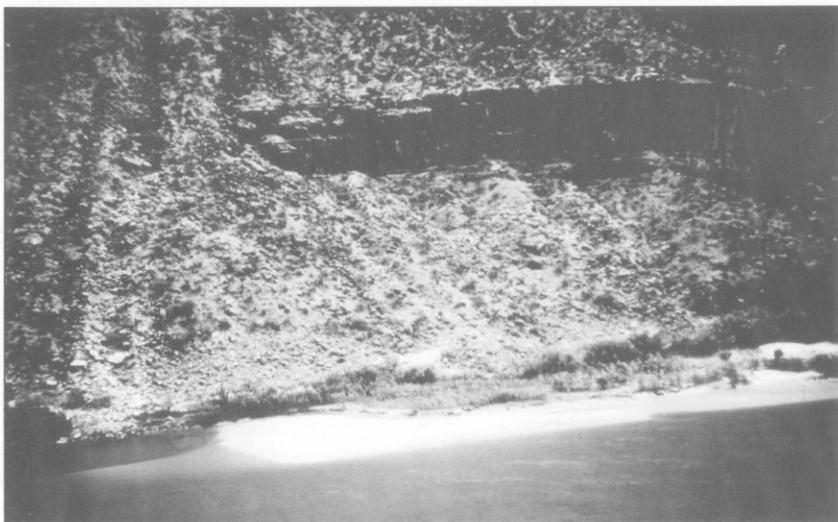
Fig. 11. Sandbar at 172.3L on 18 June 1991 prefailure.

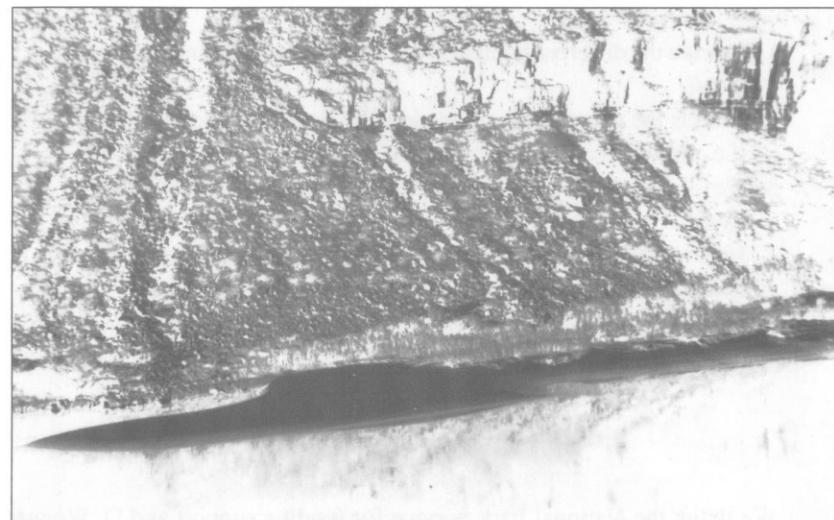
Fig. 13. Sandbar at 172.3L on 1 July 1991, approximately 2 weeks after failure and after rebuilding.

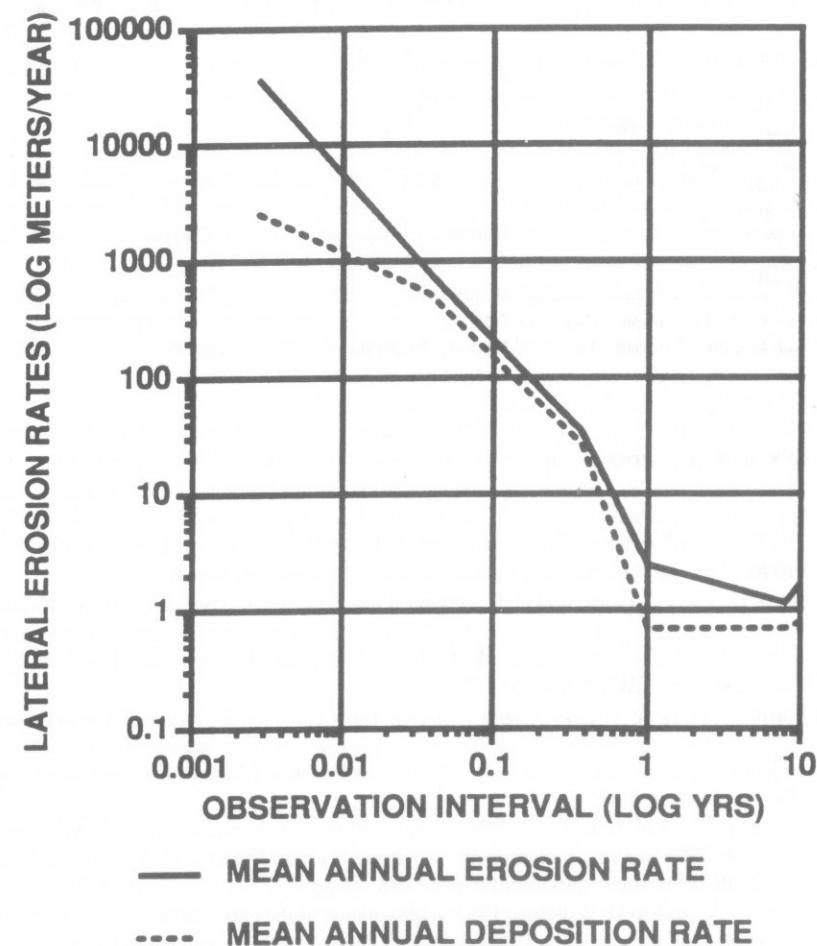
Fig. 14. Log-log scaled plot of measured lateral erosion rates versus sample frequency.

the sampling interval shortens, the maximum instantaneous erosion rates climb in a near-logarithmic increase (Fig. 14).

sively shorter interval sampling periods revealed a roughly logarithmic increase in short term erosion and deposition rates. The highly dynamic behavior of sandbars in Grand Canyon indicates the need for short-duration sampling intervals.
